Lakeview Park Beach Beneficial Use Impairment Assessment Alternatives Analysis Report

City of Lorain, Ohio

Project Number 003-019

July 2019

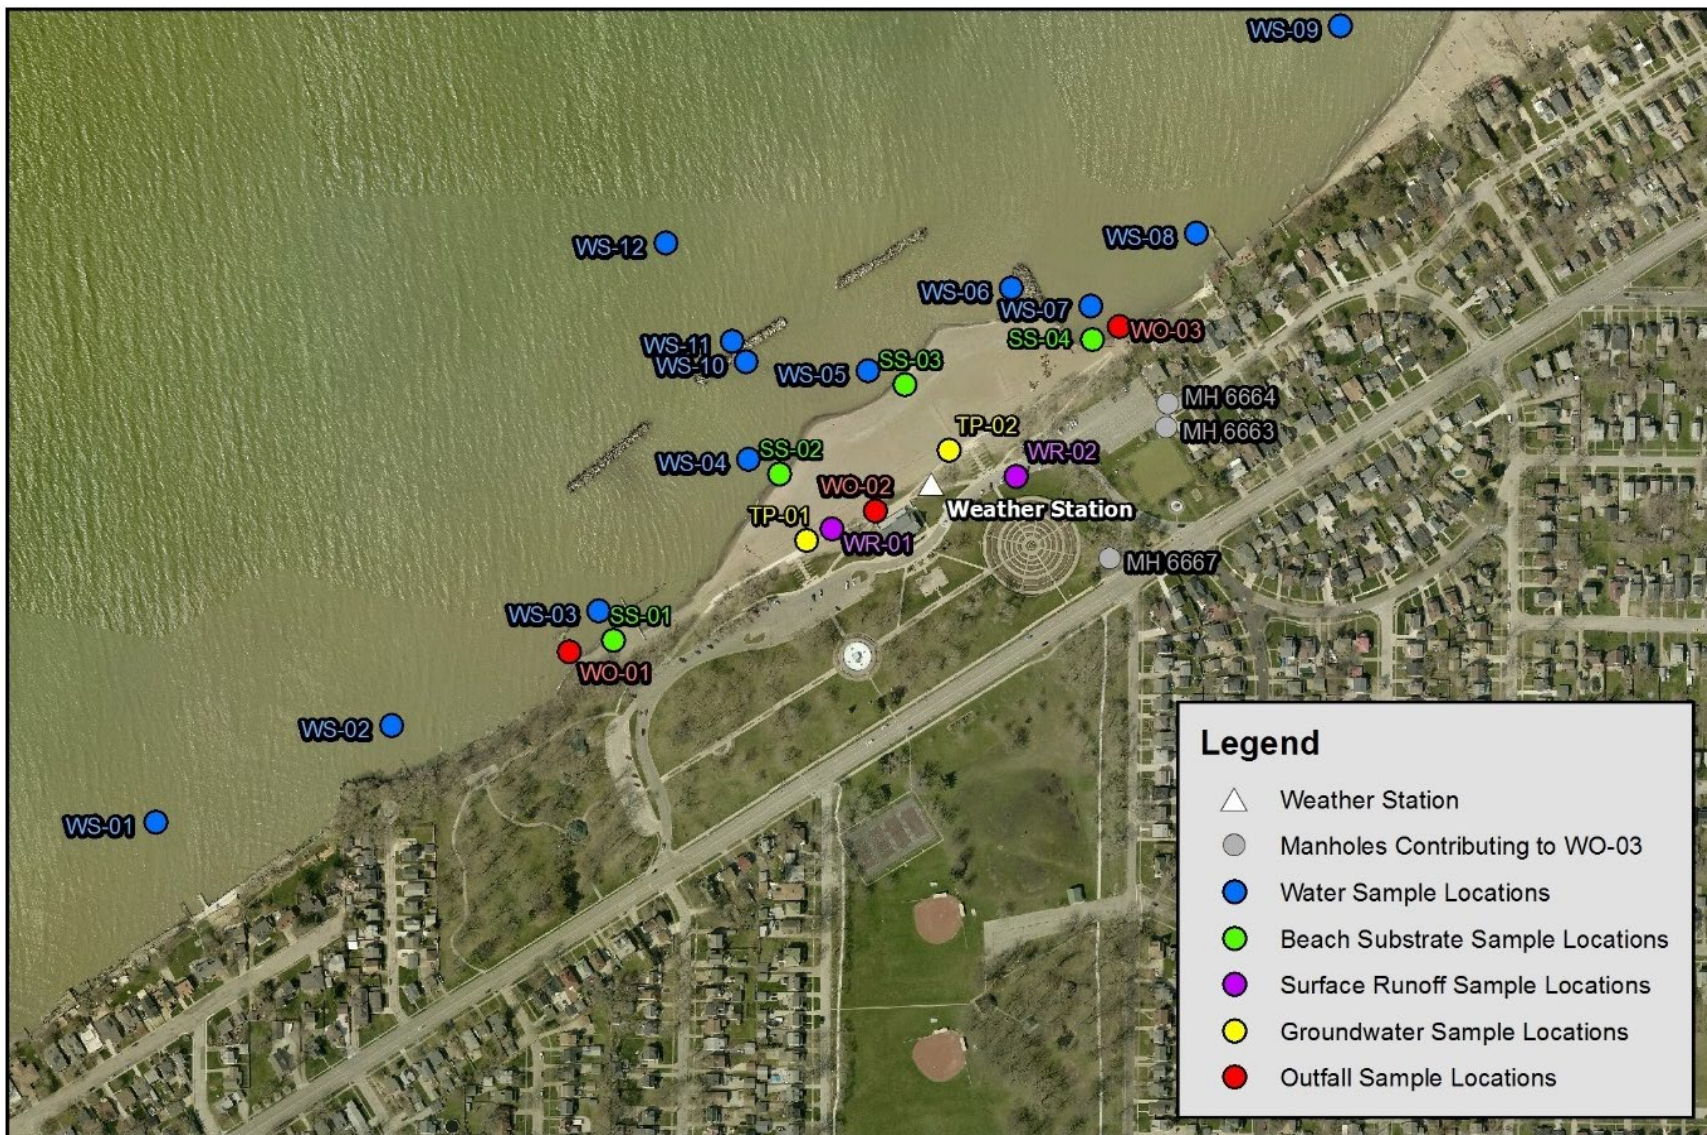
Figure 4: Sample Location Map

Three stormwater outfalls were sampled during this assessment, including two City of Lorain storm sewer outfalls located just west and east of the beach, and an outfall at the head of the beach that drains roof gutters on the bathhouse/restaurant. Runoff from the parking lot area not only sheet flows directly to the beach area, but portions also drain to either outfall. Outfalls WO-01 and WO-02 were sampled at the end of pipe by collecting the sample directly into the sample container(s). Because outfall WS-03 is located beneath a pier, the end of pipe was not accessible; therefore, three manholes that access the three tributaries to this outfall were sampled in addition to sampling the lake water just off the end of the pier. The manholes were sampled using a dedicated/disposable polyethylene cup attached to the end of a telescoping rod to retrieve the water to fill the sample container(s). Field parameters measured at each location included water temperature, pH, dissolved oxygen, conductivity, turbidity and approximate flow rate. Flow rates were estimated by observing the depth of flow in the pipe while collecting the samples.

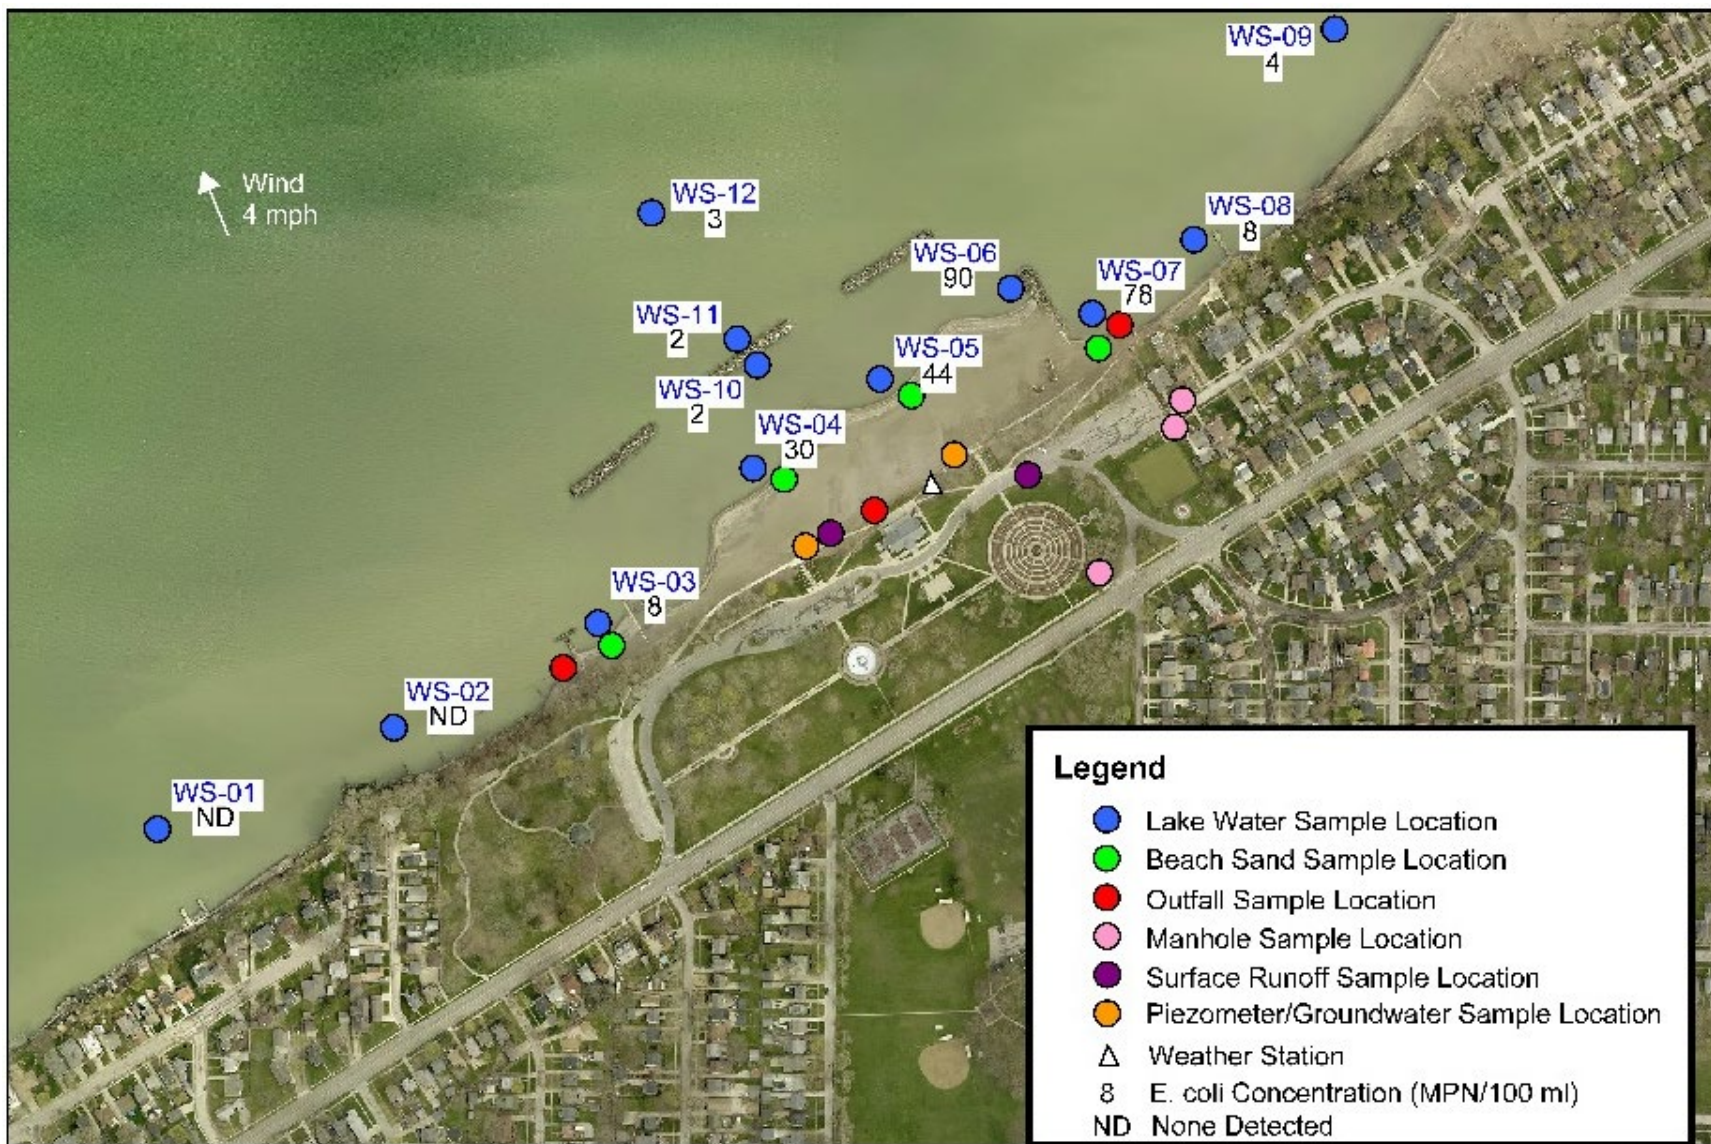
Figure 5: Sampling Event Data – Dry Weather Event (June 7, 2018)

In order to better visualize the results for the sampling program, Figures 5 through 7 show the *E. coli* results for the dry, first flush and wind events, respectively. The results from these events allowed the team to develop an understanding regarding source contributions. These observations are presented following the figures. The full *E. coli* field data generated from this assessment are summarized in the Tables included in Appendix B. These include data for lake water, outfalls, runoff, beach sand and groundwater. The *E. coli* laboratory reports are contained in Appendices F and G.

- *E. coli* bacteria concentrations in the lake water were generally higher in the samples collected along the beach than those remote samples to the east and west of the beach and those to the north outside of the breakerwaters.

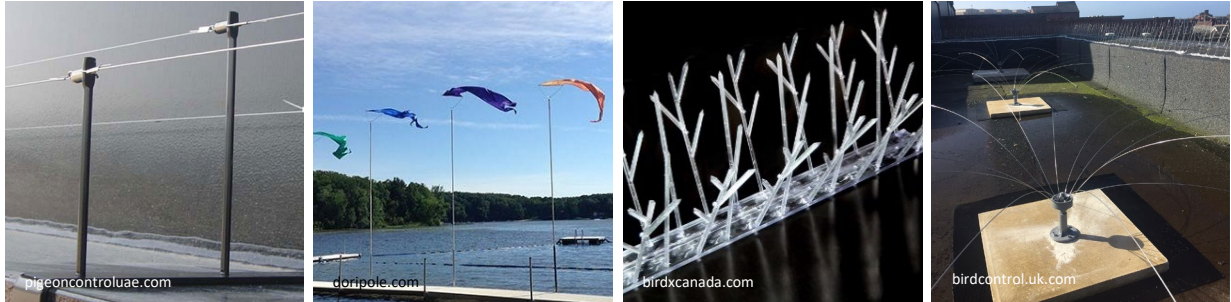
Figure 13: Examples of Bird Anti-Loafing Devices

some of these devices are shown in Figure 13. These types of devices could be placed on with the breakwaters, the roof of the bathhouse, or on the beach itself.

From left to right: wire systems, flags, spikes, spiders

The breakwaters could be augmented with spikes, flags, or the spider devices. The problem with installing these approaches along the breakwaters are their durability to wave action and susceptibility to weather conditions which in turn lend themselves to constructability concerns and potential concerns about the increase to operation and maintenance costs. Additionally, due to winter ice conditions, any controls placed on them would need to be removed before winter and reinstalled in the spring.

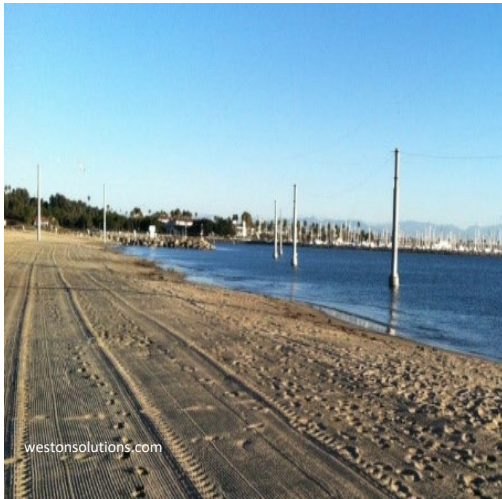
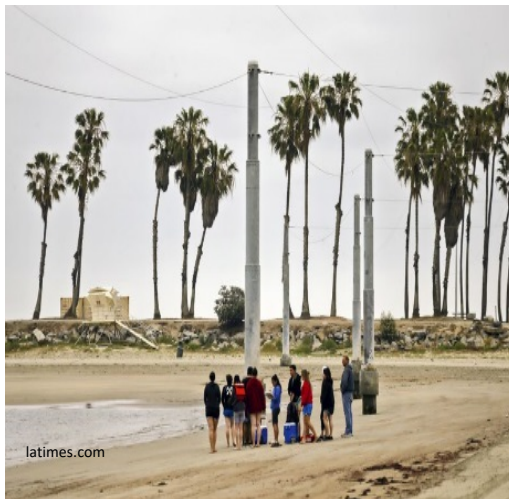
Figure 14: Examples of Aerial Cable Systems

An aerial cable system is a larger scale device that would span the length of the beach. This method is known to deter gulls flying in the general area. Similar structures consist of “long galvanized fence poles placed in a grid fashion, approximately 80 feet apart in the north-south direction and 60 feet apart in the east/west direction across the lower beach and intertidal area.” The main concern with this system is the poor aesthetics that it would bring to the beach. Examples of these systems are shown in Figure 14.

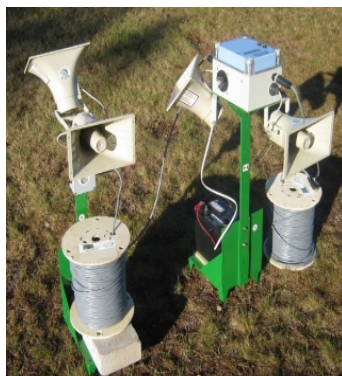
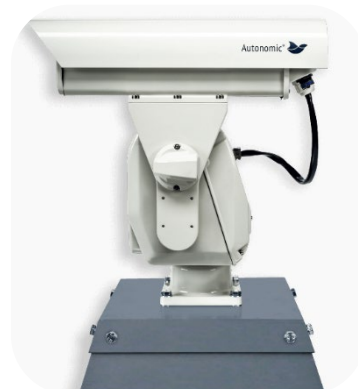
Figure 15: Examples of Bird Scare Tactic Systems

Avian lasers work to deter birds by emitting laser beams, which birds perceive as physical danger. An example is the Autonomic[®] Automated Bird Repellent Laser. These devices are typically used in private agricultural fields mounted on poles; however, there are handheld options available. The device can be rigged with a power supply or ran off a combination of battery and solar power. The Autonomic has a range up to 5 square miles and can be programmed to run at certain time slots and configurations. Manual lasers may also be used. Examples are shown in Figure 15.

Chime device: Phoenix Airport Wailer MK IV

Avian Laser: Autonomic 500 Bird Control Laser

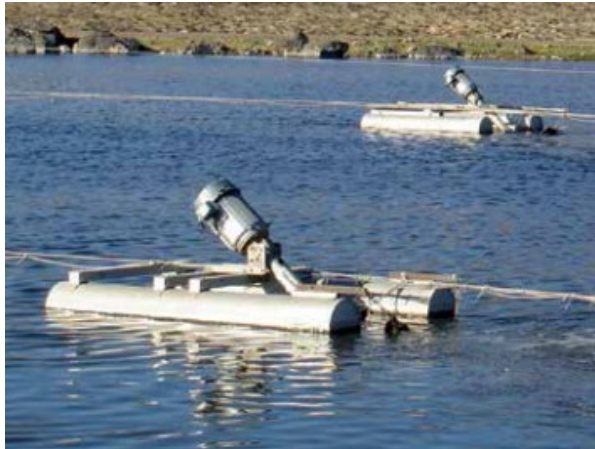
Figure 16: Circulator System Surface Float

The use of any mechanical system brings with it some implementation challenges. Power would need to be provided to the unit, likely from landside service, as solar powered options may not be possible. Additionally, the systems would need to be removed during the off-season, as they would not be able to be in the lake for the winter. This would add operational cost and complexity. Finally, users of the beach would need to be able to safely interact with any device and may be discouraged from use of the beach with the presence of mechanical systems in the lake.

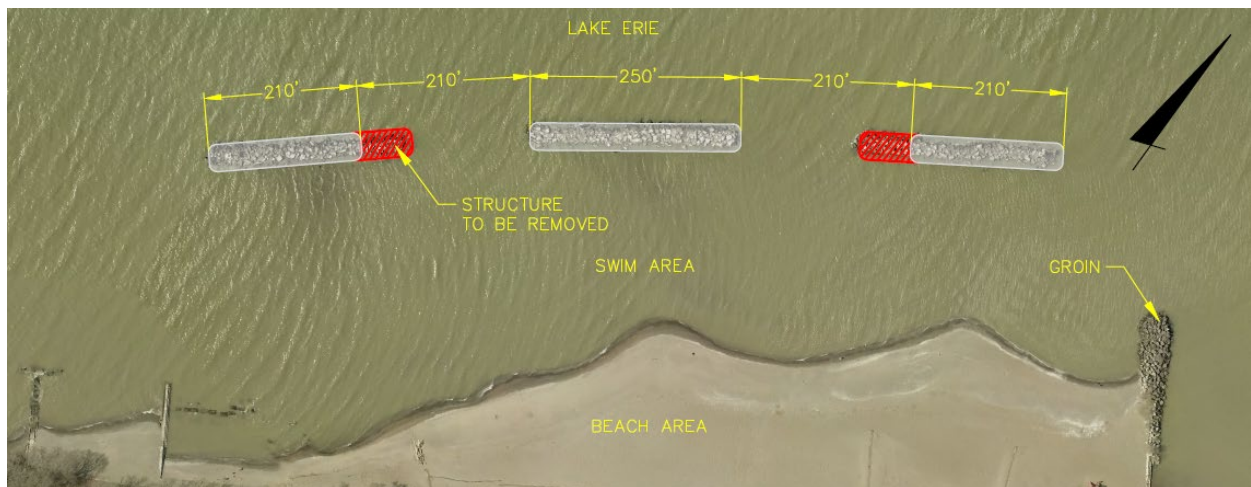
Figure 18: Breakwater Gap Widening Conceptual Plan

The other approach would be to increase the width between the breakwaters. Armor material would be removed from the interior ends of the outer two breakwaters. This would increase the width between the structures to be approximately the same width as the structures themselves. Please refer to Figure 18 demonstrating this concept. While this may increase the wave energy to promote circulation, it does come with the added risk of additional erosion. An adequate supply of material (either natural accretion or import) would need to be available to offset this potential risk.

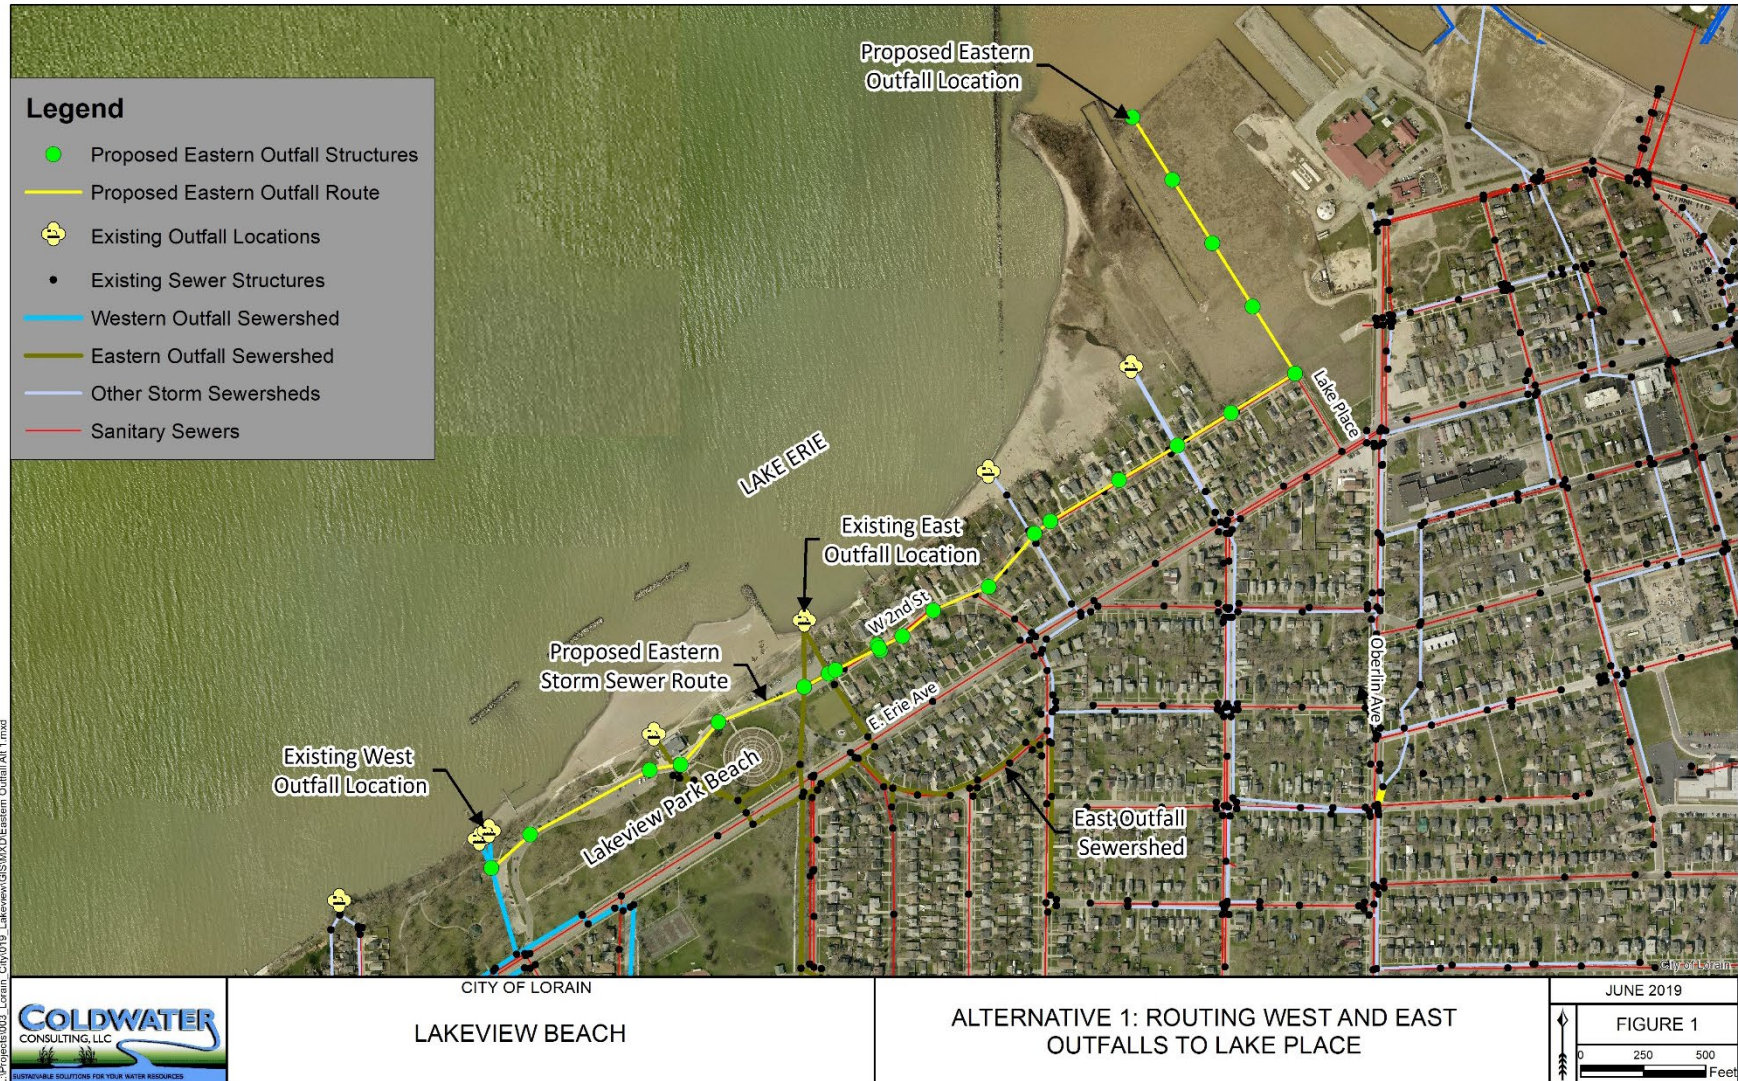
Figure 20: Alternative 1 - Routing East and West Outfalls to Lake Place

Multiple outfall locations were discussed with City Engineering staff, and the location presented here was deemed the most preferable. Other potential locations to the east were near private residences with known drainage issues. Adding a new outfall near these residences may worsen the conditions there. Additionally, it was undesirable to discharge stormwater that had known elevated levels of bacteria near private residences. The proposed location has the benefit of being far away from private residences and sits behind an existing breakwater that should limit the ability for the discharge to get to Lakeview Park Beach. Since the final portion of the proposed route is through property now owned by the City, easements would not be necessary for the route and for the outfall structure itself. The City also indicated that a benefit of an eastern route would be for potential collection of other sewer improvements that may occur in the future in this vicinity. While a specific timeframe for other sewer improvements is unknown, moving it closer toward where those are likely to occur could be preferable in comparison with other locations.

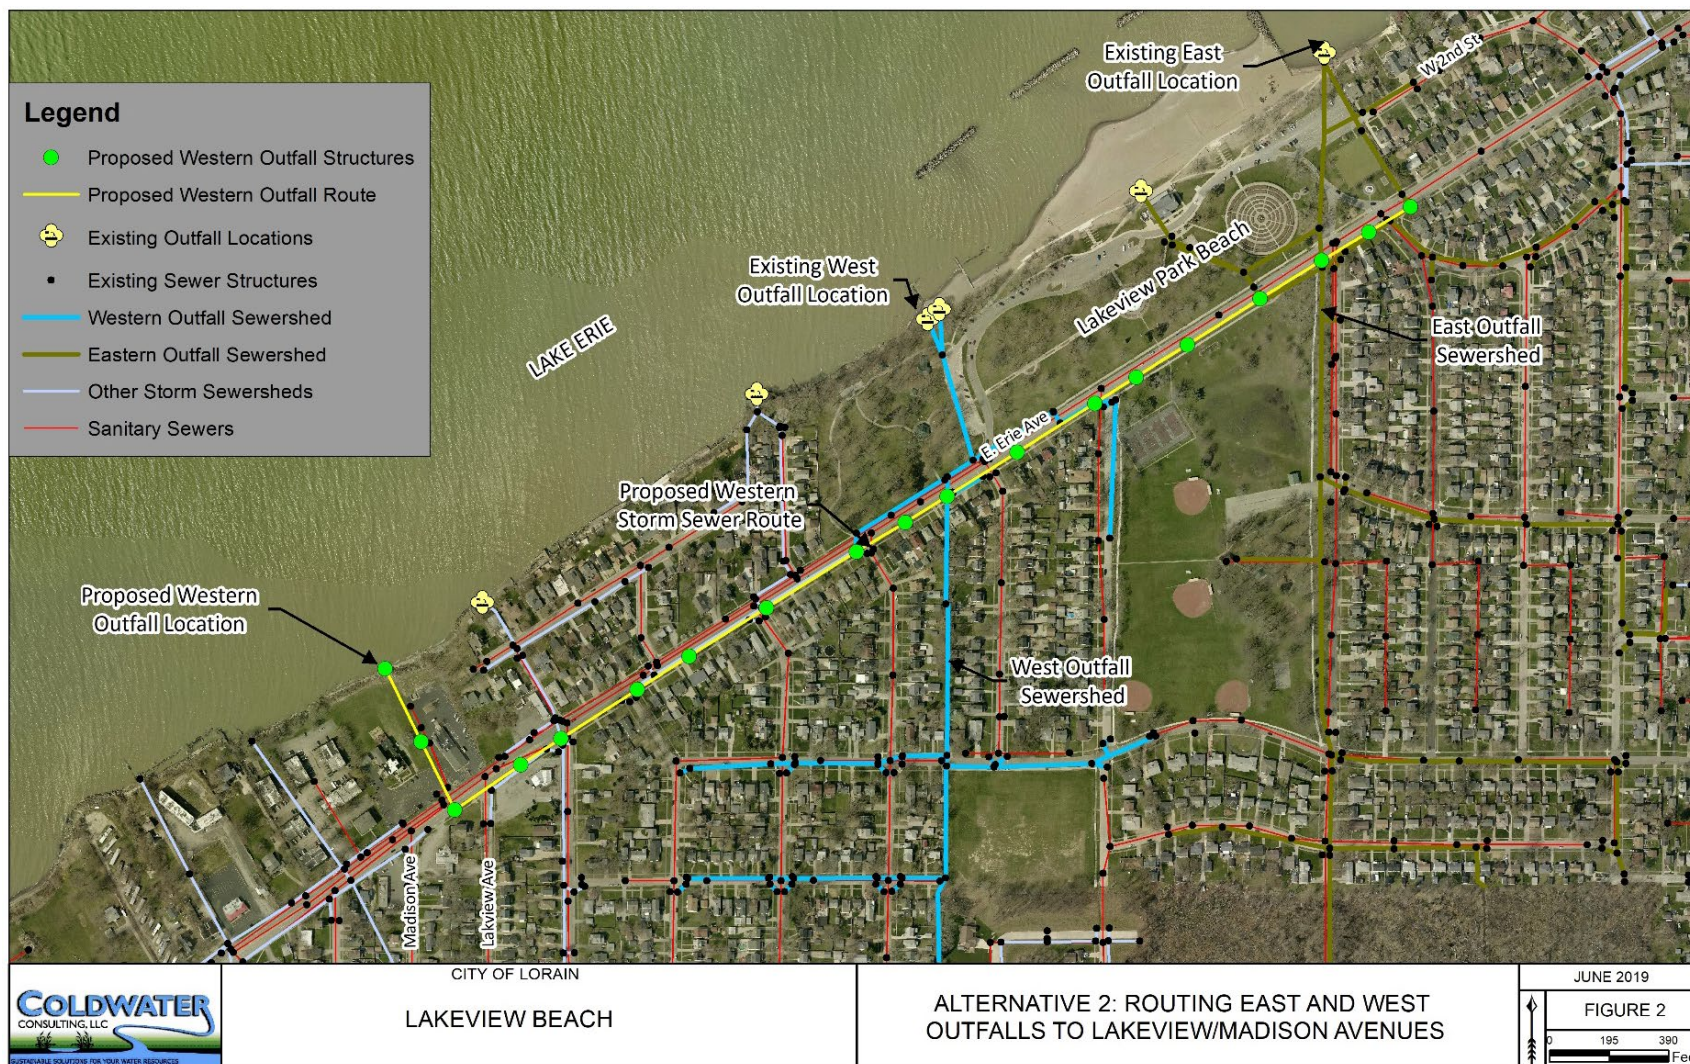
Figure 22: Alternative 2 - Routing East and West Outfalls to Lakeview/Madison Avenues

West of Lakeview Beach, there are few access routes due to the private residences in the immediate vicinity. Based on the topography and the existing utility information currently available, the proposed outfall location is as far to the west as potentially feasible. This location would be preferable due to the fact that it is not directly at a private residence, and there is vertical drop off down to the Lake and not a beach area at this location.

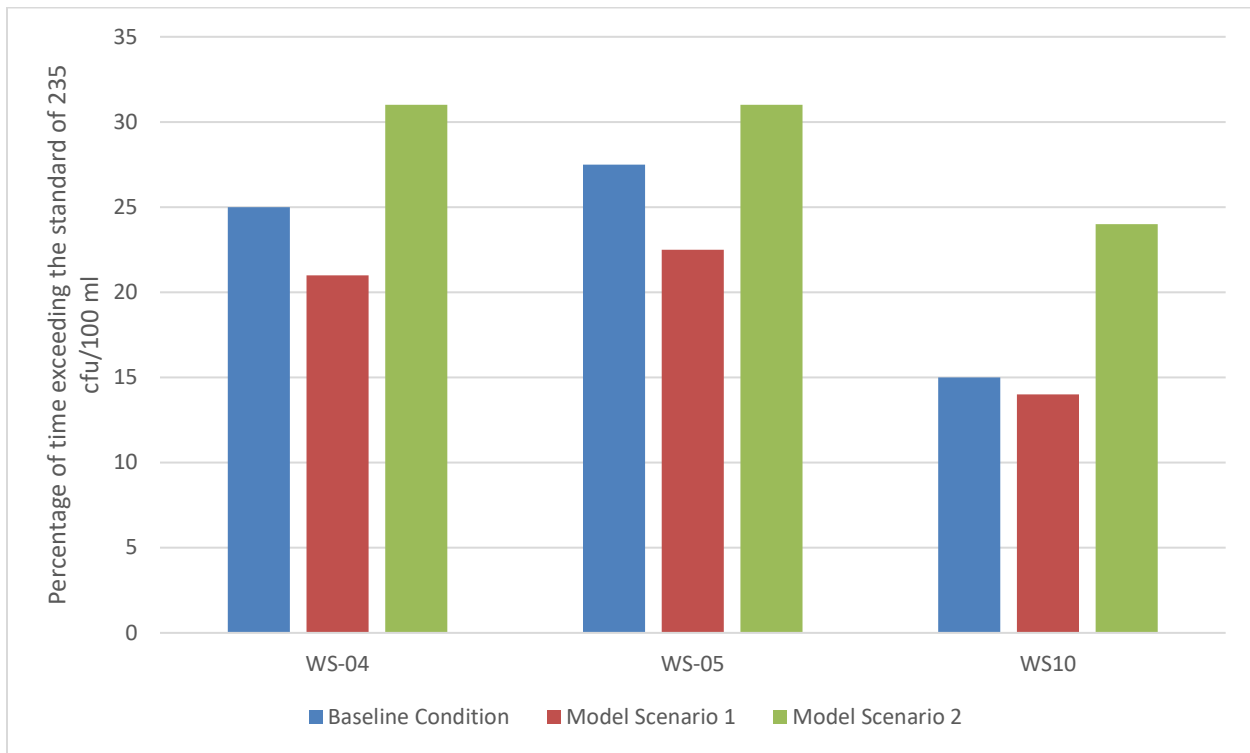
**Figure 26: Percent Time above Advisory Level – 2 Weeks Baseline
(All Loading Sources)**

Another analysis completed was to review the entire two-week baseline period against Alternative 1. Figure 26 shows the time above the advisory limit for the swim area sample locations. This comparison included loading from all sources. Again, with the understanding that the Black River and the two WWTP's were shown not to affect the beach, the loading sources shown in Figure 26 are largely birds and stormwater outfalls. Two observations in the data should be noted.

- The overall time above the advisory level for the baseline period is higher in Figure 26 (birds and outfalls) than was shown in Figure 25 (outfalls only). This is a general indication of the impact of birds on the beach water quality.
- There is very little change in time above the advisory level between the baseline time period and Alternative 1. As was shown in Figure 25, moving the outfalls was effective at reducing their impact when birds aren't accounted for. Therefore, the small change between baseline conditions and Alternative 1 shown in Figure 26 further indicates that birds would still cause a significant impact on water quality even if the outfalls are relocated.
